WARCI NEWS

Volume 22 March 2019 Issue 2

Repairing Radio Repairs Part 1

Repairing Radio Repairs

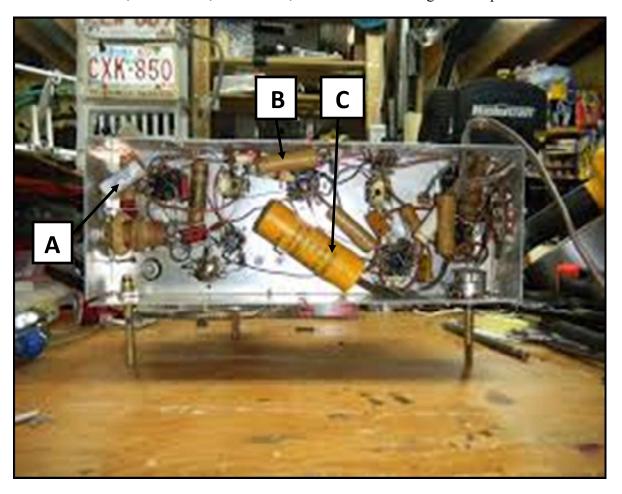
Figure 1. Capacitors A, B, C could well have been installed at three different times in this radio, and still needing recapping.

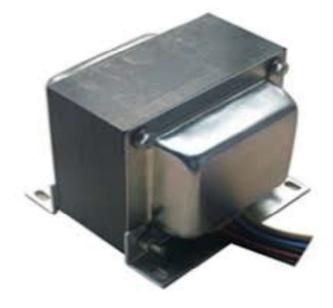
Fig. 2

Corner-bolt mount type.

Side-bolt transformer mount method, also called vertical mount.

Some power transformers have their protective steel shells attached by centered side-mount bolts, as in Fig. 3. Usually these four bolts also anchor the transformer to the chassis. Other transformer designs use only four bolts to hold the shelves in place as in transformer in Fig. 2. The Gibson transformer was of the former type, but it had fiber washers under the bolt heads at the corners, like the example in figure 4.

Now, how about the two-bolt type, shown in Fig. 3? Notice that these type transformers almost never have fiber washers under these bolts. But also notice that these bolts do not penetrate the core laminations at all, but pass through slots cut into the laminations. These bolts do not develop any power-line signal voltage between their hands, because the core doesn't not know they're there.

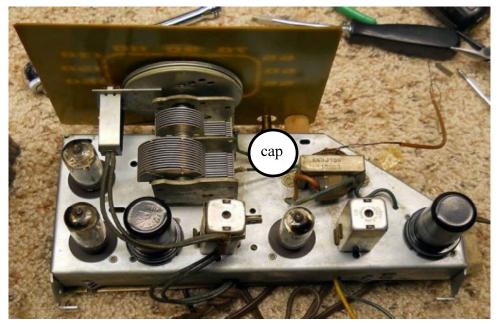
Fig 5

That repair of the Gibson hum problem made me curious about whether this casual use of the transformer mounting bolts might happen more often than one would imagine, since these bolts do seem to be handy for mounting things. I looked over a number of chassis and complete radios in the stash, and *mirabile dictu!* There it was, a Sears 101.682 chassis, taken from a broken-up Model 7070 cabinet for replacing a rust-ed-out chassis in a table model I had obtained for a dollar or two in a flea market. Some repair man had replaced the three-section main electrolytic capacitor with the new one, and he used a base clamp to mount the new cap, instead of using the twist-tab mounting disc that usually comes with the new can-type unit. Maybe his new capacitor, didn't have a mounting disc, or he misplaced it, but he had fastened the new base clamp up on the left corner of the power transformer, sort of as I sketched on the writers chassis drawings shown in figure 5.

Someday I should get around to installing that Sears chassis in the radio. It's a ten-tube set with push pull 6V6 outputs that simulates a Midwest, with several wasted 6J5 tubes just the goose that tube count.
